**Flood Control Project Maintenance
Levee Inspections**

Maintenance Issue Types Only, Levee Inspection Report By Mile - Spring 2015

Sutter Maintenance Yard Maintenance Area 0007

Waterway	Bank	Unit Miles	Inspection Start/End	Inspector
Unit No. 01 Feather River	Right	11.90	05/05/2015 05/05/2015	Michael Pitta

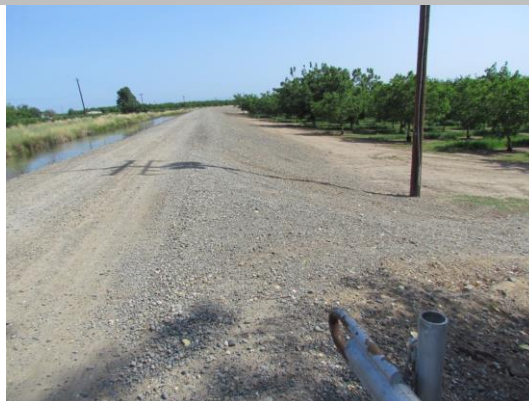
Photo 1 of 1 : SP_2015_MA0007_200_47_20150505_00017.jpg

LM Start	0.01	Rating **	A	Issue No.	47
LM End	1.77	Issue Type +	Ma	Location *	WS
Category	Earthen Levee			GPS Latitude/Longitude	
				Start	End
Item	Vegetation			39.311097 °	39.335015 °
				-121.637638 °	-121.633808 °
DWR ID	DWR_MA0007_01_s_2015_47				
Action/Comments					
Control annual grass and weeds on the levee slopes and easements.

The view of the vegetation was taken on the waterside facing upstream.

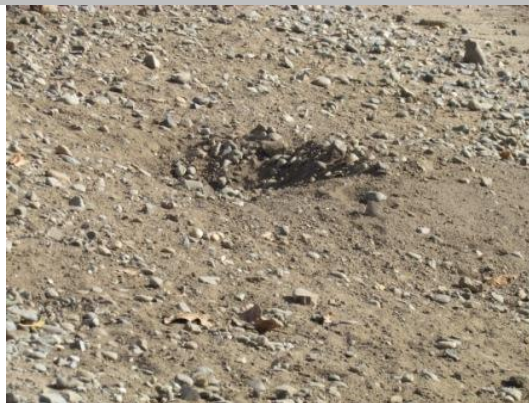
Photo 1 of 2 : SP_2015_MA0007_200_217_20150401_00014.jpg

LM Start	0.48	Rating **	M	Issue No.	217
LM End	0.48	Issue Type +	Ma	Location *	WS
Category	Earthen Levee			GPS Latitude/Longitude	
				Start	End
Item	Animal Control			39.317050 °	39.317050 °
				-121.633331 °	-121.633331 °
DWR ID	DWR_MA0007_01_f_2013_217				
Action/Comments					
No rodents visible, but rodent burrows visible; need to backfill and compact or grout burrows.					
Inspector Comments: Rodents holes were observed but no rodents visible at time of inspection.

Up close photo of said rodent holes. Fall 2013.

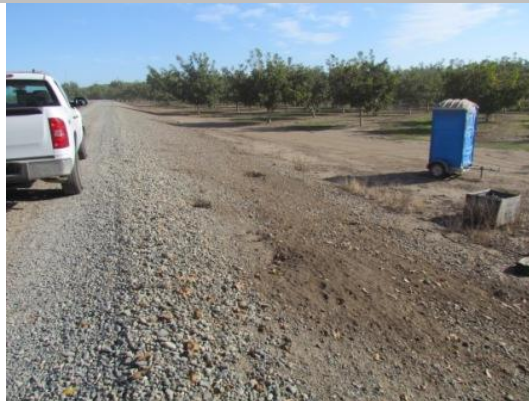
Photo 2 of 2 : SP_2015_MA0007_200_217_20150401_00015.jpg

LM Start	0.48	Rating **	M	Issue No.	217 (cont)	
LM End	0.48	Issue Type +	Ma	Location *	WS	
Category	Earthen Levee			GPS Latitude/Longitude		
				Start		End
Item	Animal Control			39.317050 °	39.317050 °	
				-121.633331 °	-121.633331 °	
DWR ID	DWR_MA0007_01_f_2013_217					
Action/Comments						
No rodents visible, but rodent burrows visible; need to backfill and compact or grout burrows. Inspector Comments: Rodents holes were observed but no rodents visible at time of inspection.

This photo was taken from the crown of the levee facing north looking down the slope at rodent holes. Fall 2013.
